Service Manual

Brewer MkIII • Spectrophotometer

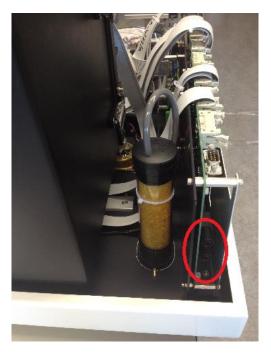
1) A digital Volt-Ohmmeter, capable of measuring from 1 mV to 2000 volts DC. For voltage measurements it is recommended to use the ground connectors on the mainboard, see photo.

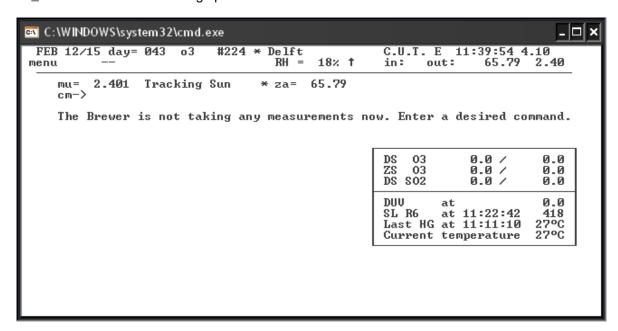
When the Brewer Software (version 4.10) is launched it should briefly show the message 'Merging da_lo.rtn' and then should bring up the main screen.

Some older versions of the Brewer software run the FR routine before going into the main screen. The main screen design is also slightly different. If the main screen is shown then communication has been established between the Brewer software and the control computer.

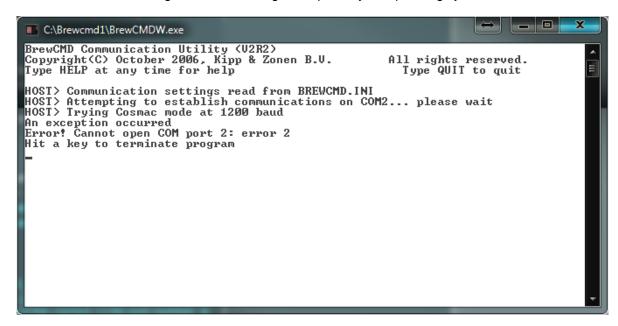
The fastest way to check the serial port is to run the Brewcmdw.exe file. This utility cycles through all possible mode and baud rate configurations of the Brewer until communication is established. This file is normally found in the Brewcmd folder. If the following error screen appears, then the COM port is not properly set up in the operating system of the PC. Double check the Brewcmd.ini file if the correct COM port number is set. To resolve this, make sure the COM port set in the Brewcmd.ini file is a recognized and working COM port in your operating system.

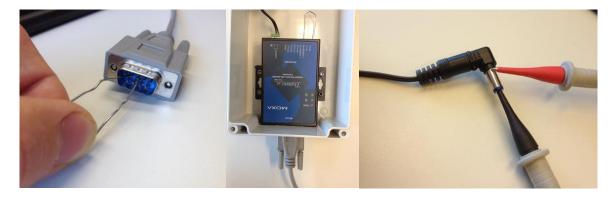
Another way of testing the RS-422 converter at the computer is by removing the communications cable from the converter, connecting pins Tx+ and Rx+, plugging the converter into the Computer COM: port, and checking for echo-back as in step 3. Now switch connections to pins Tx- and Rx- and test again. The RS-422 converter is operating correctly if characters echo back. If a fault is indicated, then the converter, serial cable, or the power module is defective.

Each line of the serial cable can be tested for continuity by measuring point to point with a ohmmeter, The power module output should be approximately +12V (the centre pin is negative.) If the voltage is normal, then replace the RS-422 converter and test again.

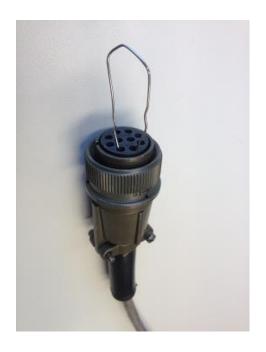
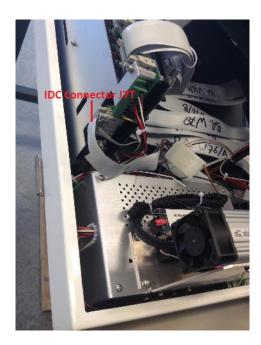
As an alternative for testing cables, each line can be tested for continuity by measuring point to point with an ohmmeter, using the appropriate schematic as a guide. The resistance through the surge arrestor is 10 ohms so that a typical resistance should be 12 ohms from the RS-422 converter to the IDC connector at the Brewer Main Electronics board.

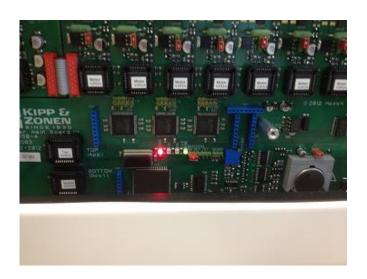
There is a Red status LED labeled 'CODE' located near the bottom middle of the board - it should be flashing slowly in 'Cosmac mode' as per the following table. If the Brewer is in some other mode, change back to the Cosmac mode (step 10).

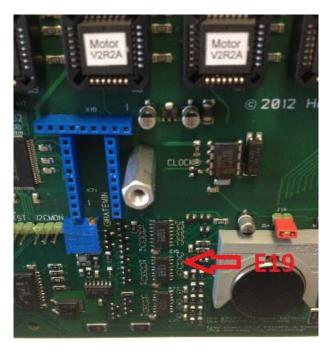
Send the command to turn the Standard Lamp circuit on (B2), and measure the voltage at E19 on the Main Electronics Board. The voltage should be around +3 volts when the lamp is on and 0 volts when the lamp is off. If this voltage does not change, the Main Electronics board should be replaced, or Kipp & Zonen consulted.

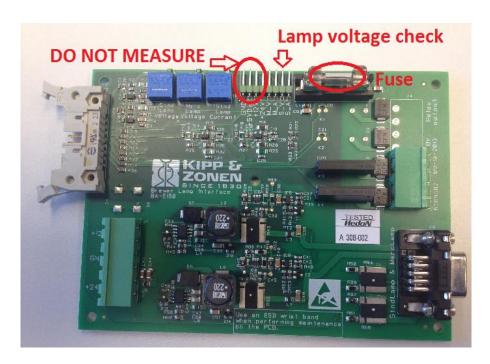
If the cable is good, the Lamp Control Board should be tested for correct operation. First check the fuse on the lamp control board. The standard and mercury lamp circuit voltage should be check. This can be done by probing the measurement pins in the right part of TP1 on the top part of the lamp board. DO NOT use the left pin as the ground for this measurement, as it can get in contact with the voltage pins next to it and cause a short circuit. Instead use the grounding points on the main board or the power supply cover as the ground. The pin second from the right is for the standard lamp voltage and the pin fourth from the right is for the mercury lamp voltage. Turn the lamps on with the commands B1 and B2 for the mercury and standard lamp respectively. The measured voltage should be around 3 V for the lamp that is on. If this is not the case, the complete board must be replaced. Refer to the lamp control board schematic Fig 10.4-2.

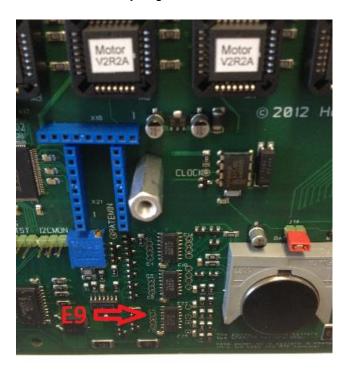
Replace the Spectrometer cover, and remove the cover from the Main Electronics board. Measure the high voltage test point E9 on the main electronics board (see picture), if it is not the same as the value given in the Final Test Record, section 4.4, then adjust R4 on the high voltage control board, until you get this value.

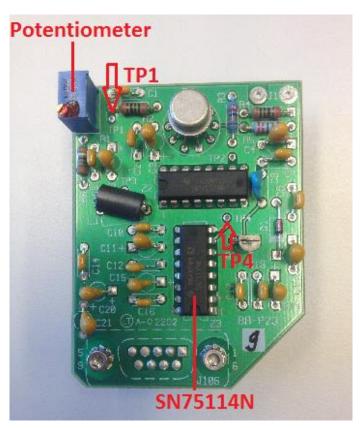
If the high voltage is correct, there may be a failure in the high-speed amplifier board. A schematic of the board is shown in figure 10.6-4.3. TP1 on the high-speed amplifier board (inside the PMT housing) should read -10 millivolts (referenced to the HV connector shield). If the value of this test point is incorrect, an adjustment of the on-board potentiometer can be attempted. If this test fails, the high-speed amplifier board should be replaced.

If this test point is normal, the photon counter cable should be inspected to ensure that all connections and wires are intact. Finally, an oscilloscope can be used to monitor test point TP4 on the high speed amp board, and then pins 1, 2, 3, 4, and 12, 13, 14, 15 of the IC, SN75114N. There should be clean square waves, the frequency of which should vary with light intensity.

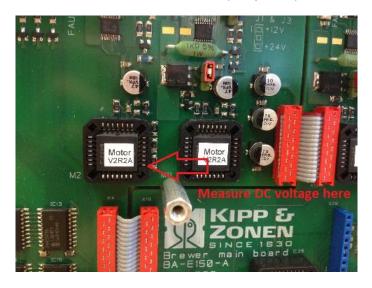
With a DC voltmeter, monitor the sensor voltage at the last bottom pin on the right side of M2 on the Main Electronics Board (see picture)

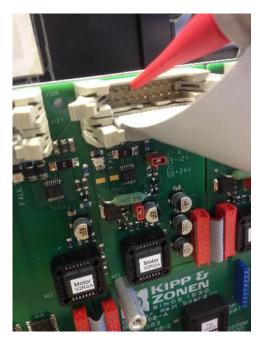
- 1 Connect an Oscilloscope or Voltmeter to pin 1 of Connector P201 of the Board BA-C99 in the Tracker (lower left of the tracker board BA-C99).
- 2 From the Brewer Main Menu, go to the TeleType mode (TT or MM command).
- 3 Send the Command M,2,1000 and pulses should be observed.
- If no pulses are seen at the Tracker, then try pin 2, J17B on the Main Electronics board. This pin is the 2nd from the left on the top row of solder connections

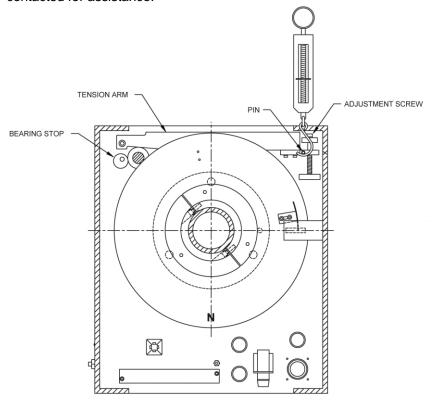
A spring scale can be used at the top and bottom of the shaft and the tension adjustments set to 4kg at the top, and 9kg at the bottom tension point.
